# Landowners & Fisheries Group

# Alde & Ore River Walls

# Bringing the flood defences up to standard

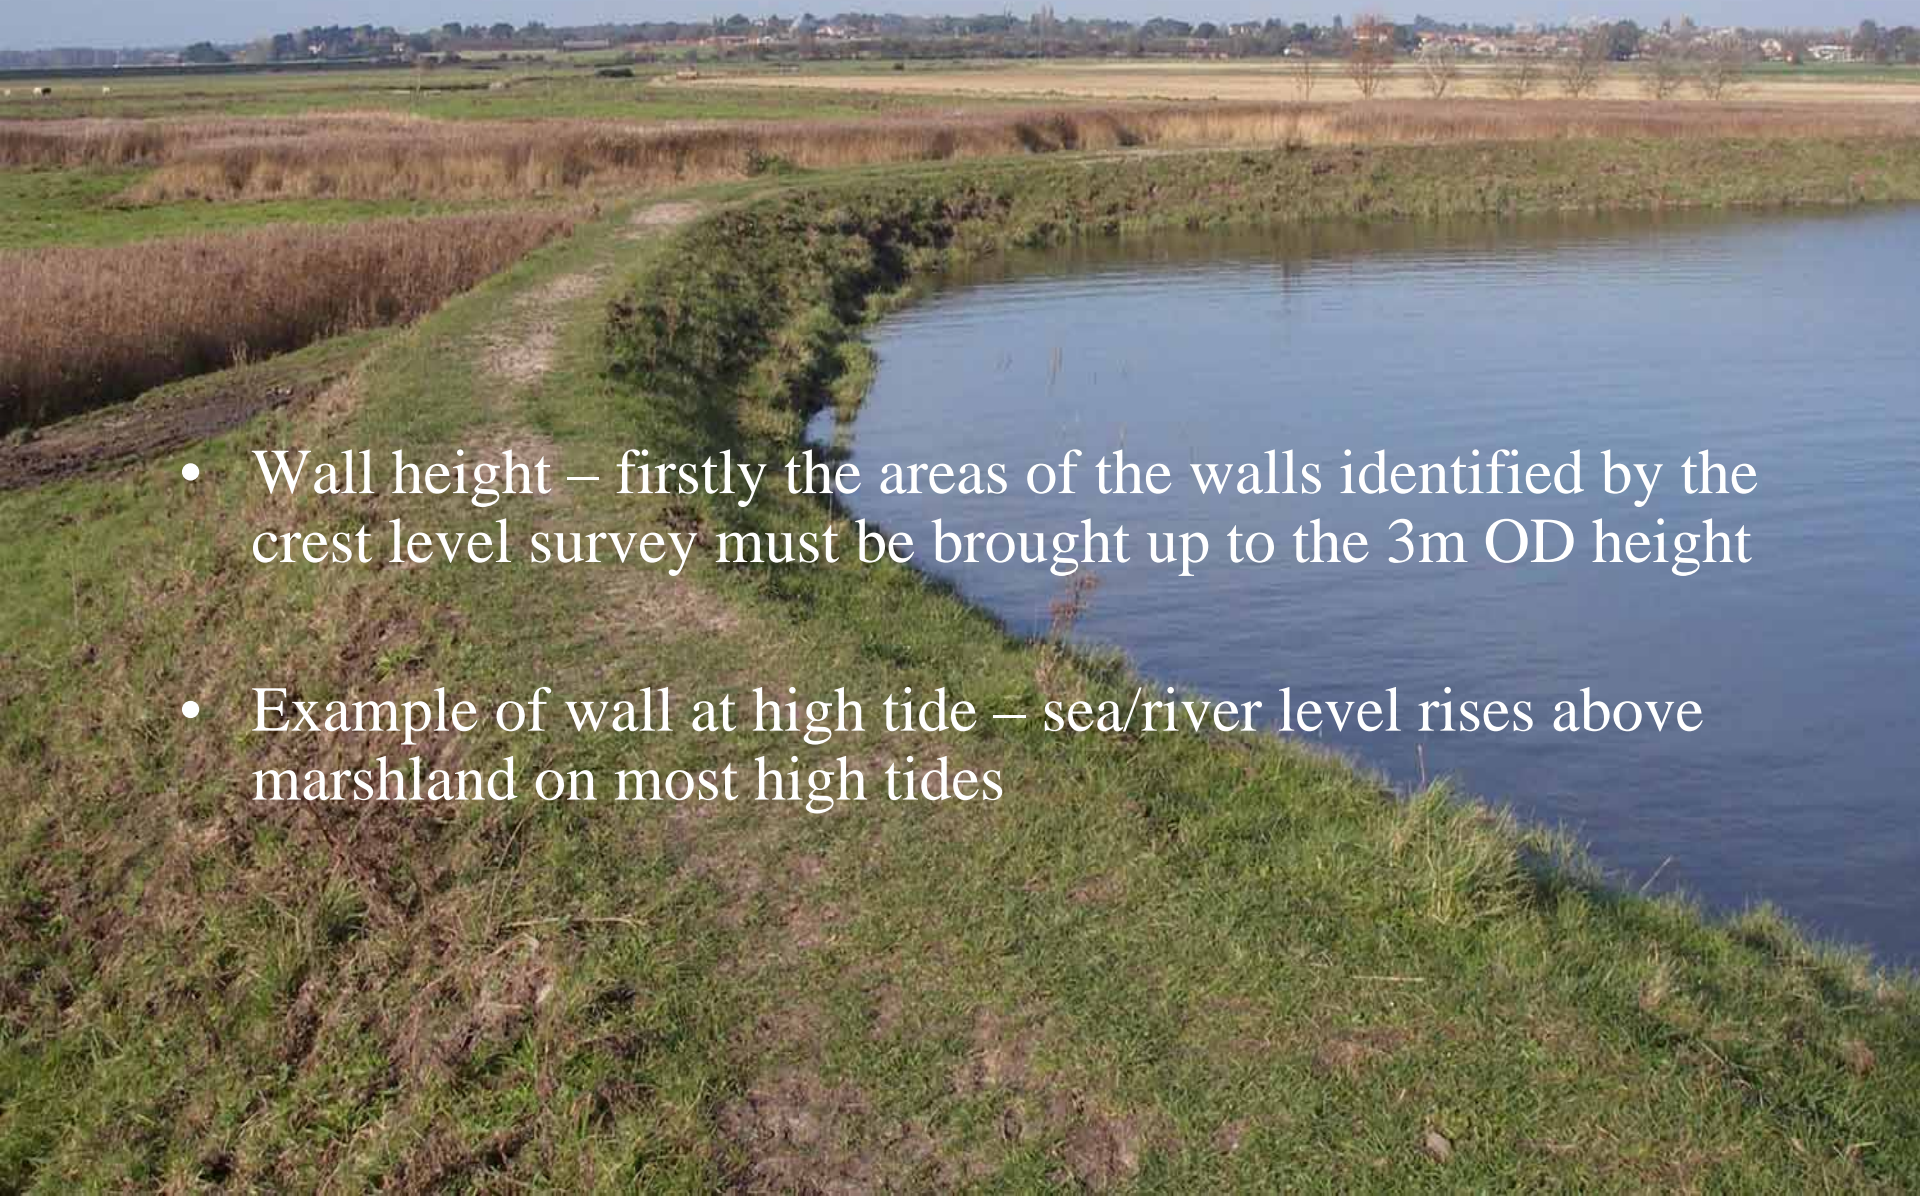
- Wall height – firstly the areas of the walls identified by the crest level survey must be brought up to the 3m OD height
- Example of wall at high tide – sea/river level rises above marshland on most high tides

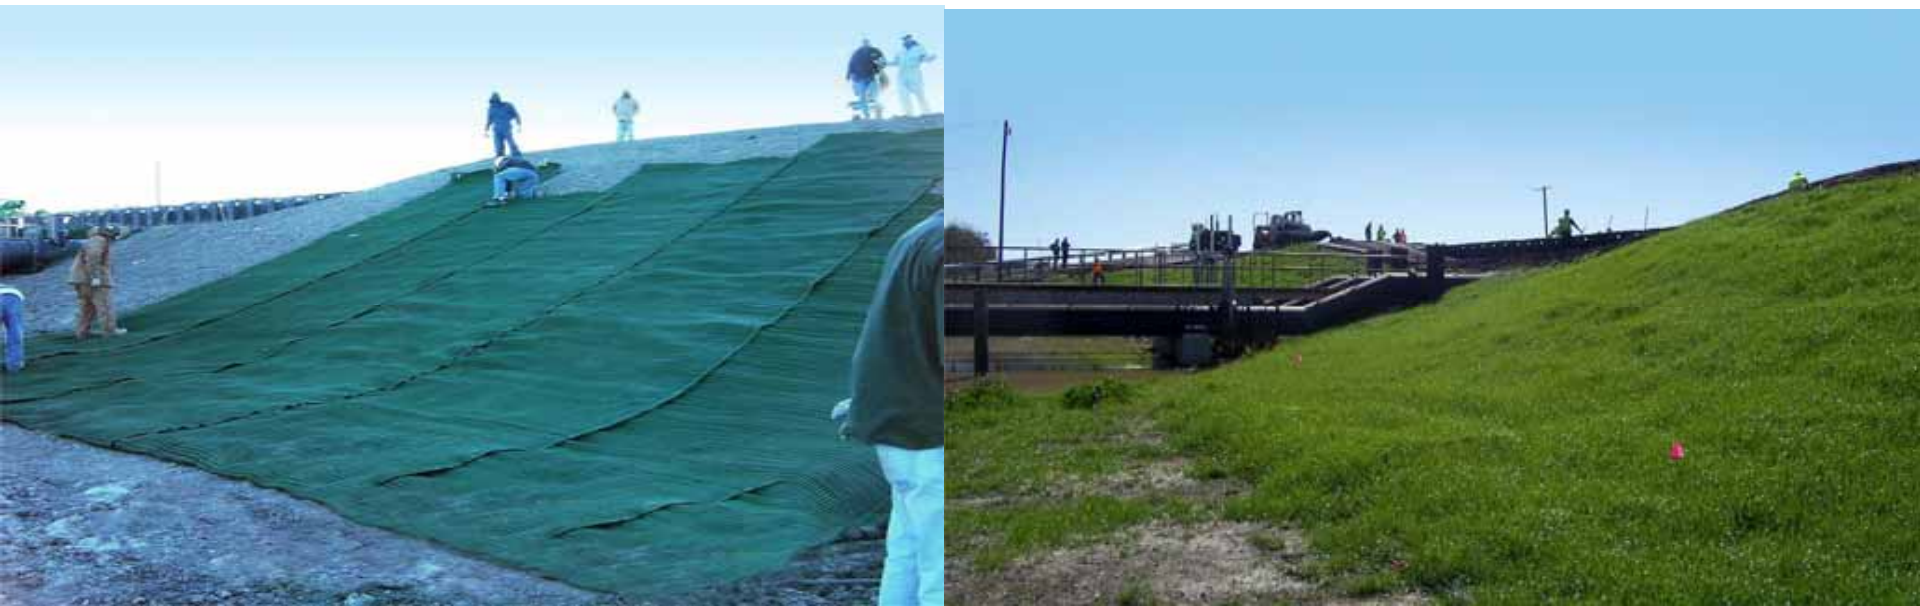
This is a project in Alabama, post Katrina upgrade. Here the levee (river wall) has been re-profiled to a slacker slope and the gang is laying out turf reinforcement which was anchored in place.

Image 2 shows it 12 months on, fully grassed up with a massive resistance to sustained over topping as a result.

Bringing the walls up to a modern standard to withstand a major event with overtopping being accepted at certain points
